Assessment of Dam Safety of Coal Combustion Surface Impoundments

Coletto LP, LLC

Coletto Creek Power, LP

March 11, 2011

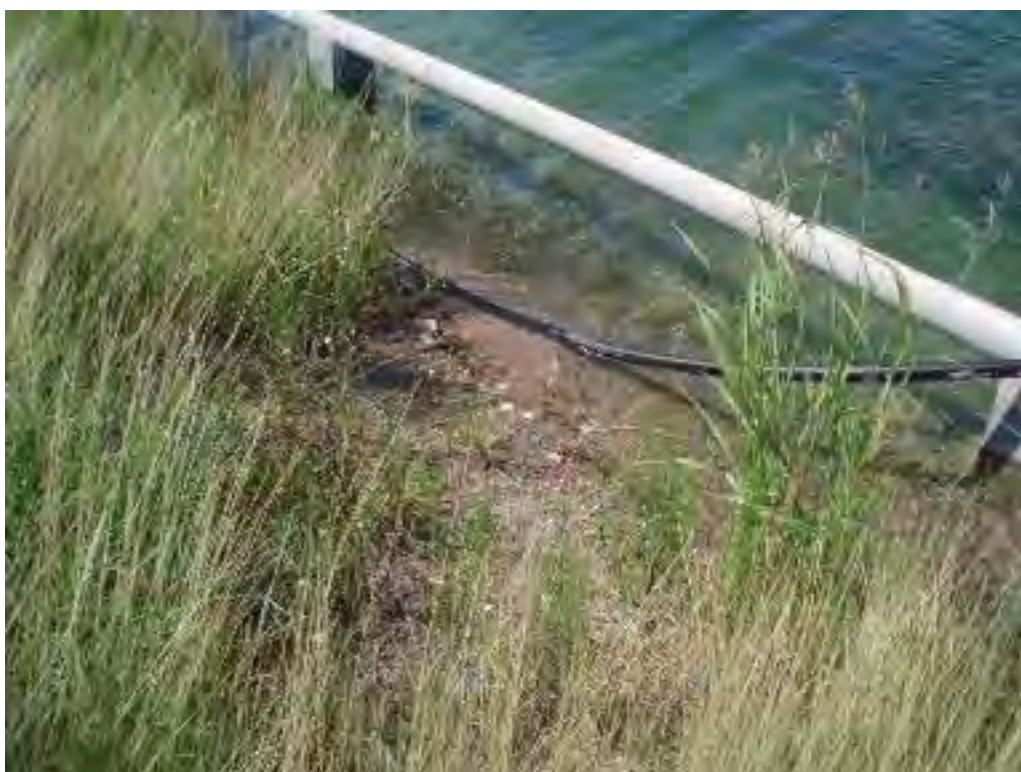
No riprap was observed on the interior slopes. Grass and brush approximately 24 to 36 inches tall was observed growing on the top 1 to 2 feet. Below, the soil was exposed and there was approximately 1 to 2 feet of erosion from wave action (Photos 4 and 43).

Photo No. 4: Secondary Ash Pond - Northeast slope of divider embankment, looking at typical erosion area from wave action. Erosion area shown approximately 6'Wx2'D.

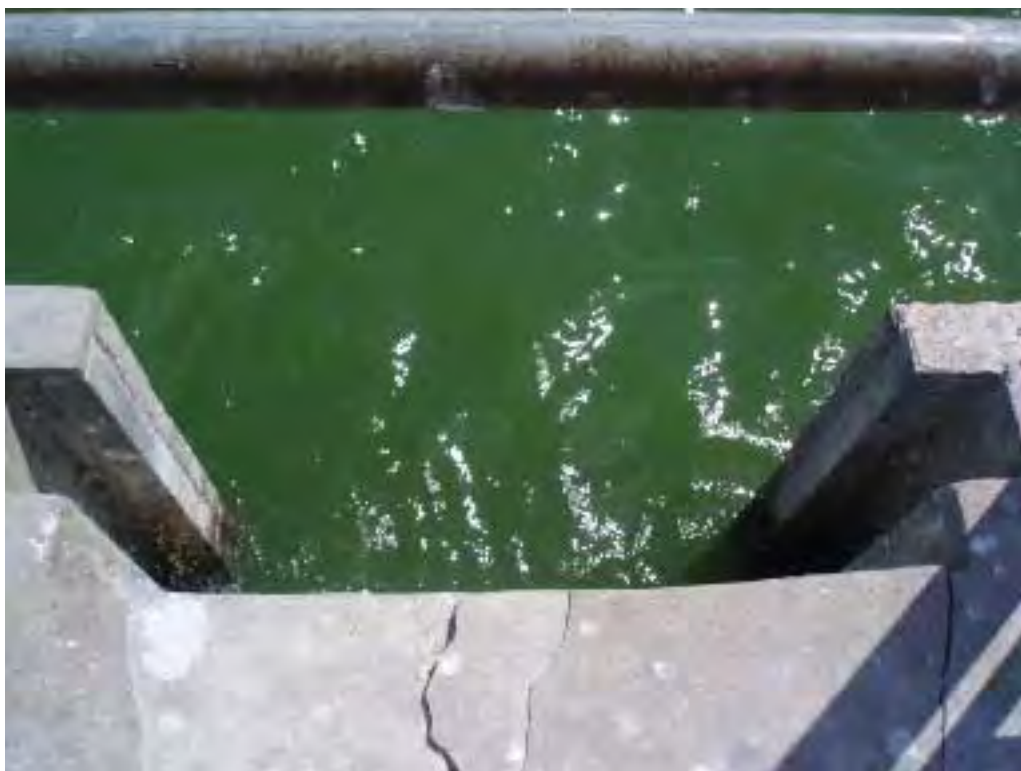
The inlet structure in the Primary Ash Pond appeared to be in fair condition (Photo 6, 7, and 8). The inlet structure was clear of debris. Some cracking in the concrete around the top of the intake structure was observed (Photo 7). The remainder of the structure above the water level and the catwalk appeared to be good condition.

Photo No. 7: Stop-log slots on inlet structure.

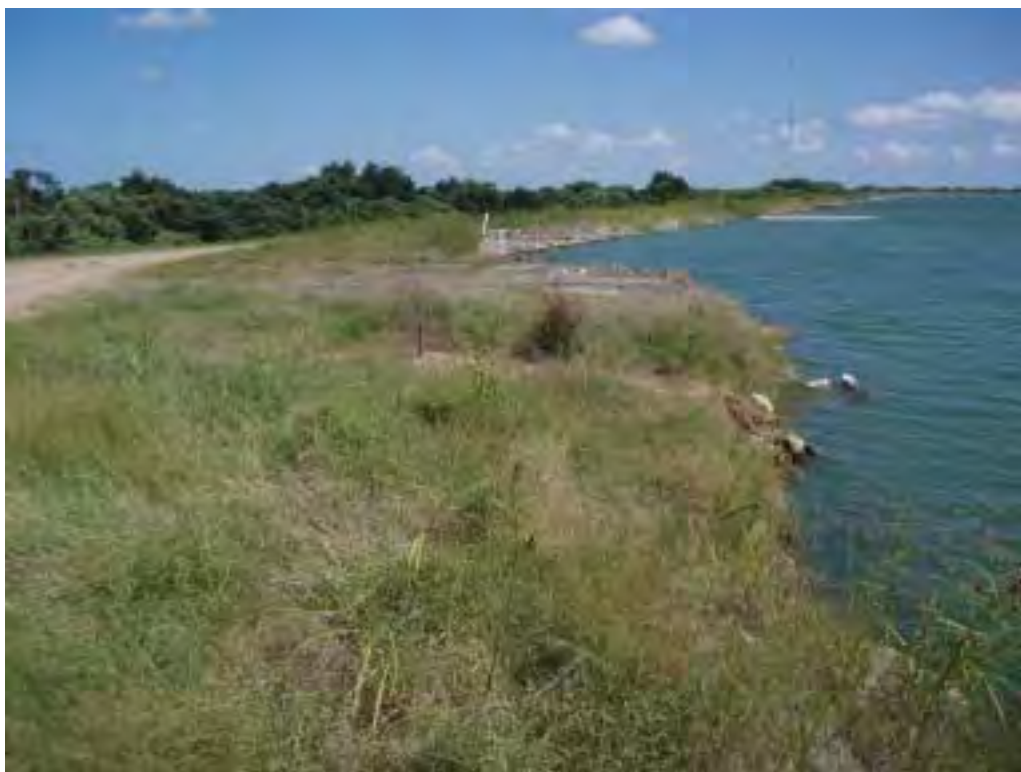
Two areas on the east embankment were observed where BMT has dumped excess flyash and bottom ash and pushed the material into the Primary Ash Pond (Photo 12).

Photo No. 12: Primary Ash Pond - East interior slope, looking southeast. Note areas where Boral trucks have dumped excess material on the interior slope.

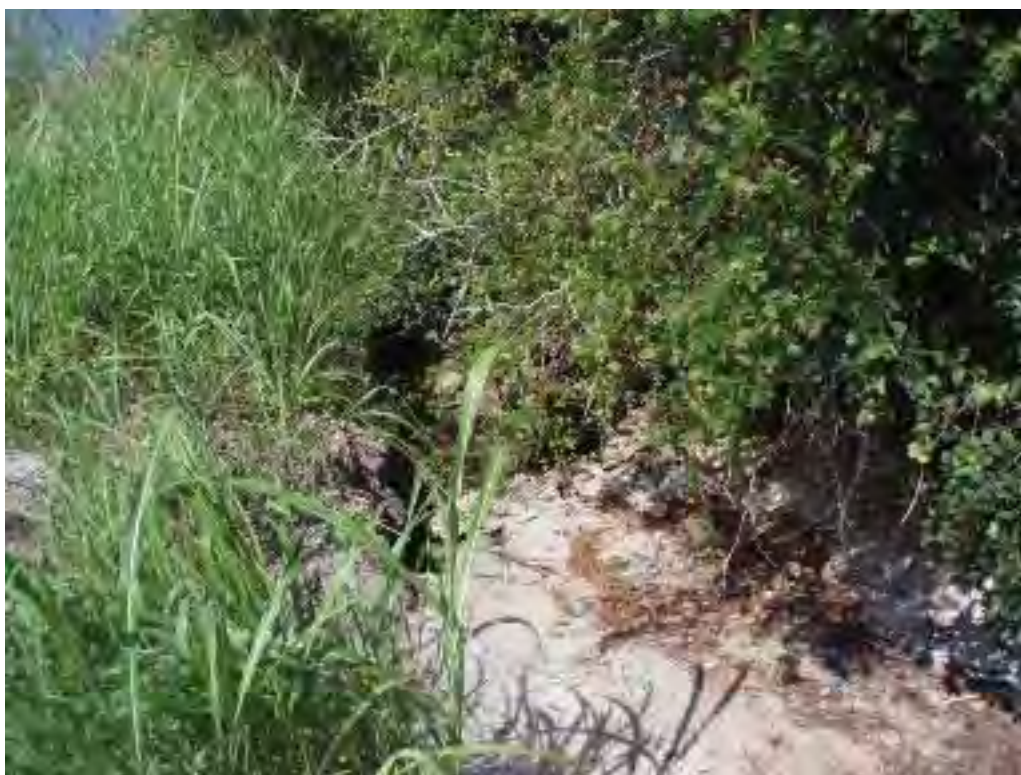
Photo No. 22: Overview of outfall channel. Note channel is deteriorated. Concrete is cracked, spalled, and missing and there is exposed soil.

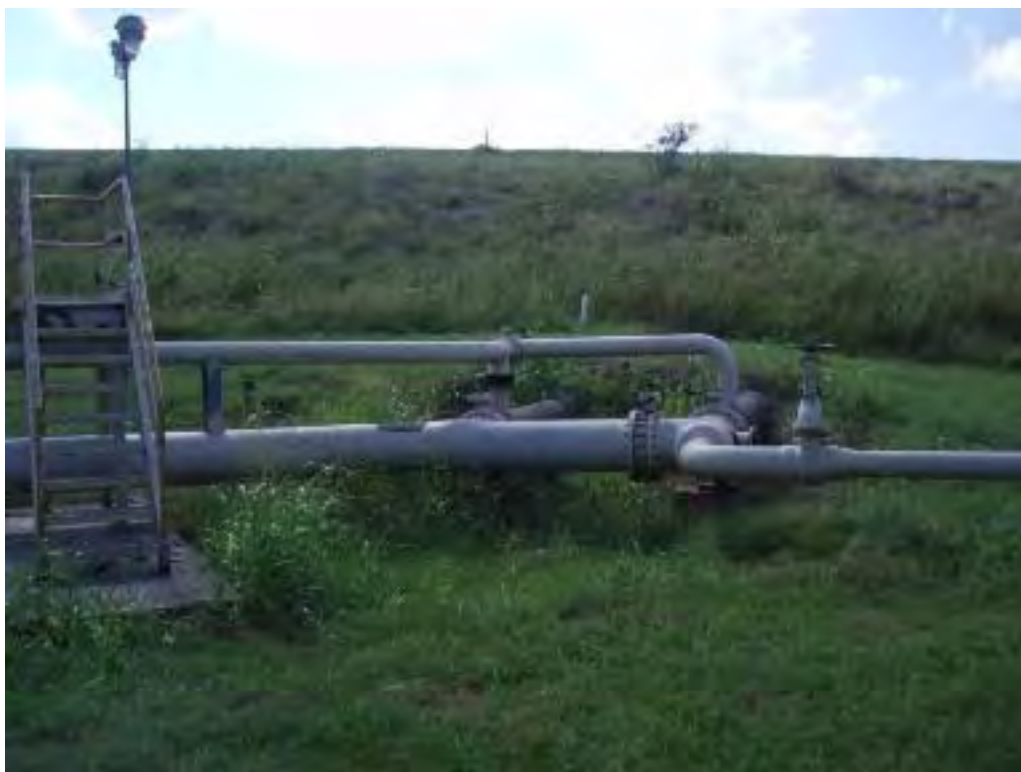
Seepage was observed at the toe of the east embankment exterior toe. The discharge sump for the subsurface drain seepage collection system was observed adjacent to the recirculating pump station (Photo 23). Flow was visually estimated to be approximately 5 gpm in the sump through a 2-inch-diameter pipe.

Photo No. 23: French drain discharge sump at toe of Secondary Pond near outfall. Estimated flow approximately 5 gpm through a 2-inch-diameter PVC pipe.

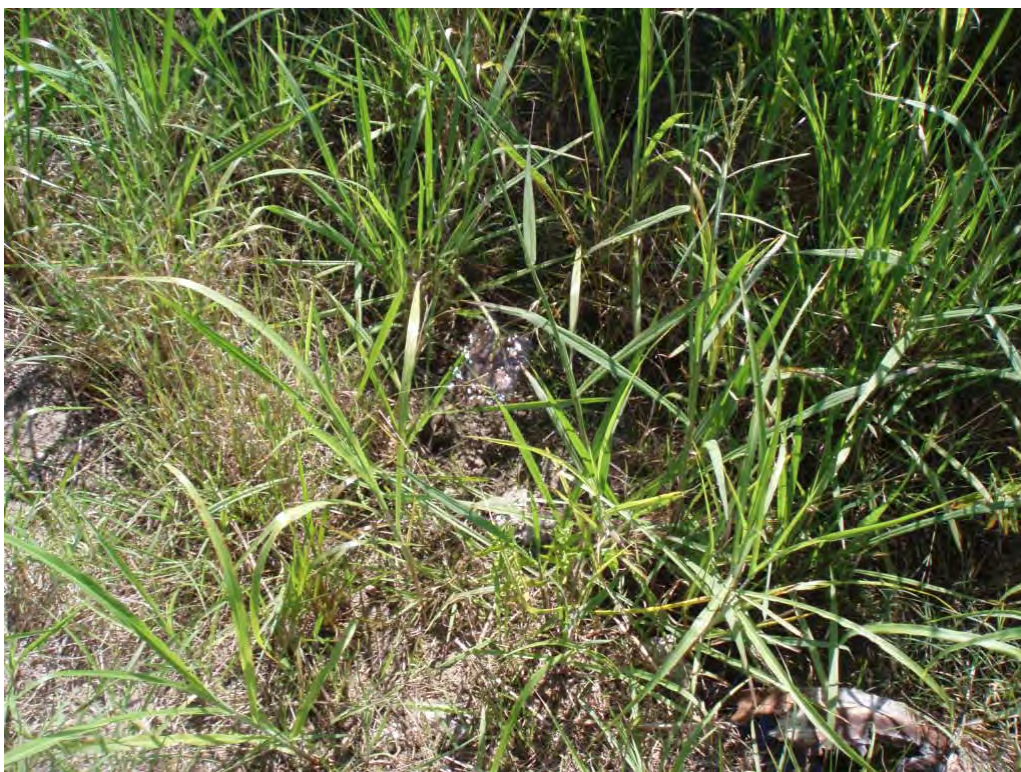
More seepage was observed on the east embankment near the recirculating pump station. The sump pit for a subsurface drain seepage collection system was observed to the south of the pump station (Photo 25). The visually estimated flow from the sump pit through a 4-inch-diameter PVC pipe was averaging approximately 50 gallons per minute (gpm). A seep was also observed on the inside of the access road to the pump station (Photo 26).

Photo No. 26: Primary ash pond - East embankment exterior slope, looking at seepage at toe
near French drain.

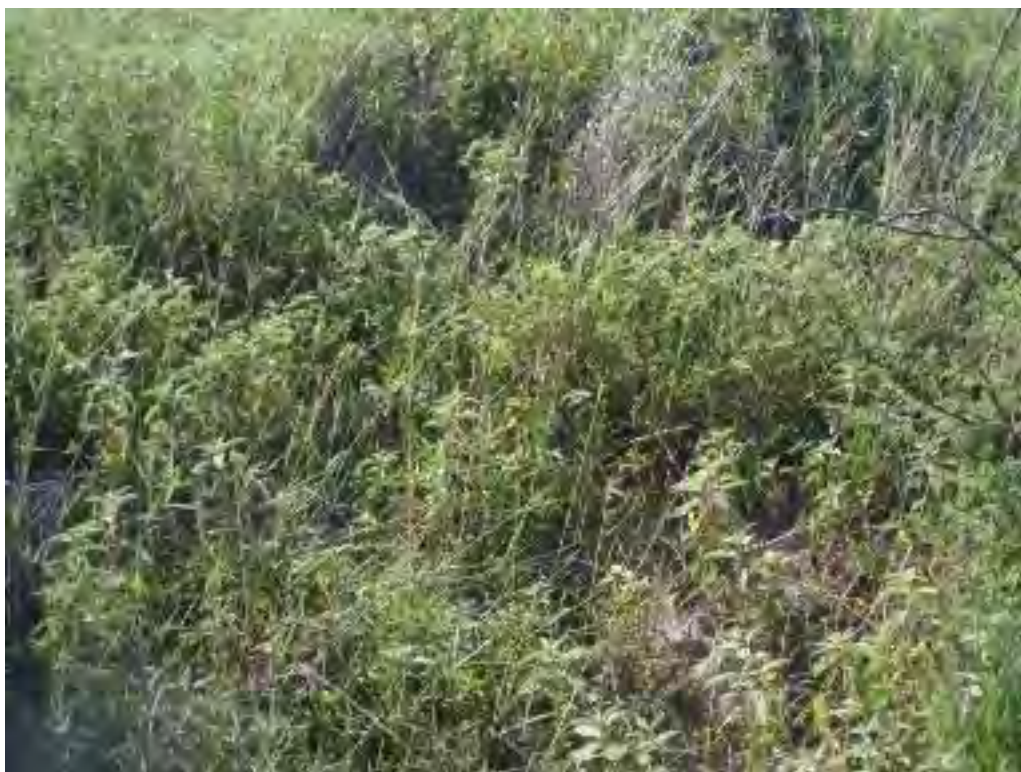
Multiple depressions were observed on the north and east embankment exterior slopes (Photos 28, 30, 31, 32, and 36). The depressions ranged in size from 4 to 8 feet long and up to 3 feet deep. The depressions appear to be grown in erosion rills because no displaced material was observed below the depressions. Multiple erosion rills were observed at the toe of the north embankment exterior slope (Photo 33, 34, and 36). The erosion rills ranged in size from 6 to 10 feet long and up to 3 feet deep.

Photo No. 28: Secondary Pond - East embankment exterior slope, looking at 4'Wx2'D depression.

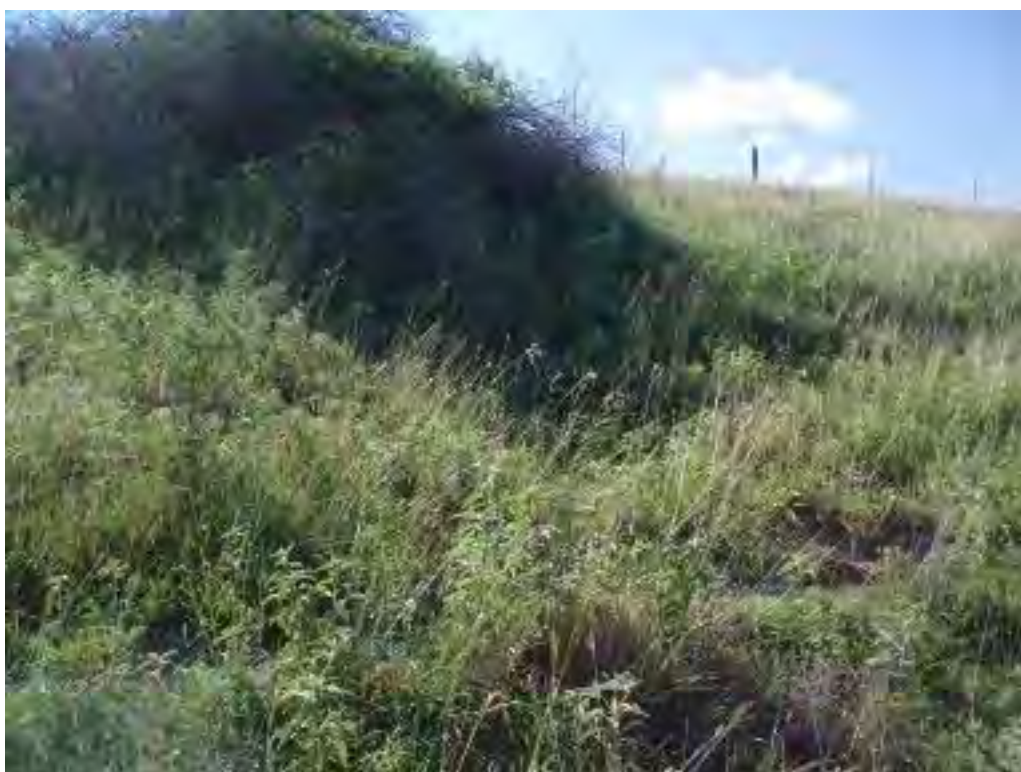
Photo No. 30: Secondary Pond - East embankment exterior slope, looking at 8'Lx8'Wx2'D depression.

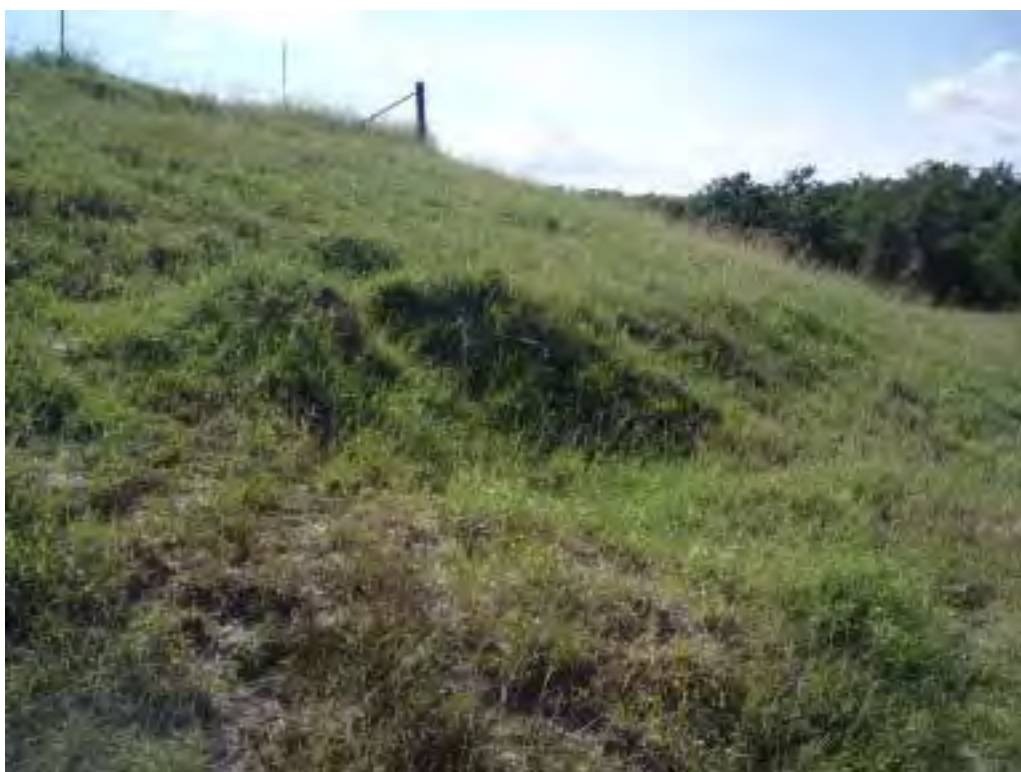
Photo No. 32: Secondary Pond - North embankment exterior slope, looking at 8'Lx8'Wx3'D depression.

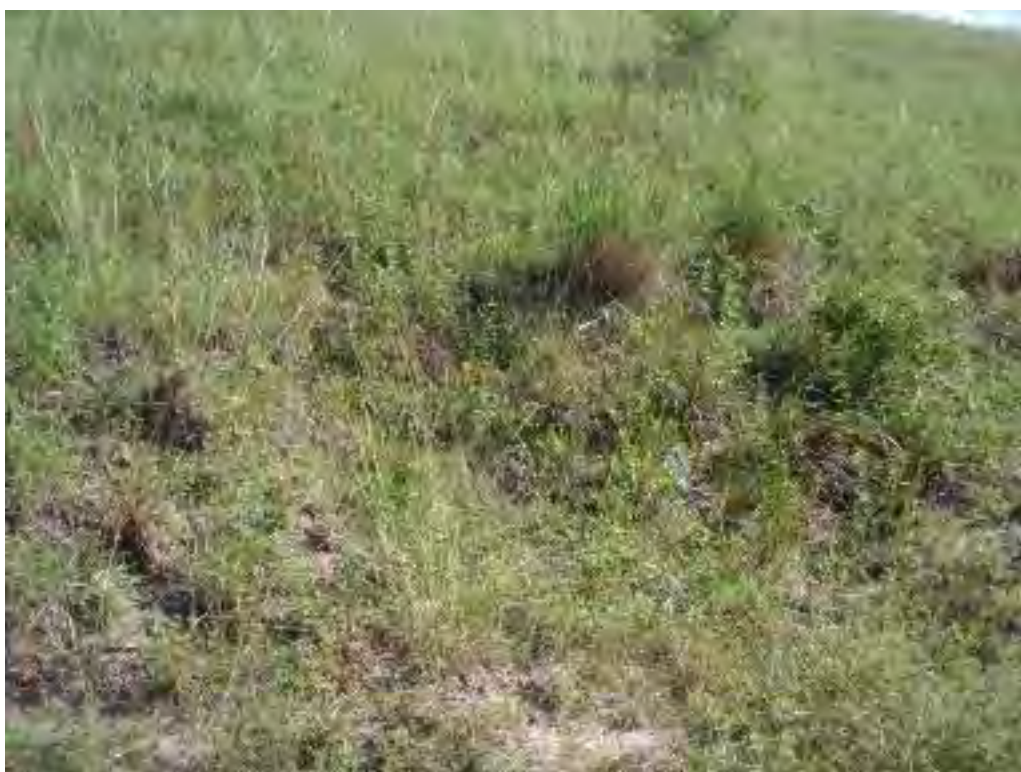
Photo No. 36: Secondary Pond - North embankment exterior slope, looking at 6'Lx4'Wx2'D erosion rill.

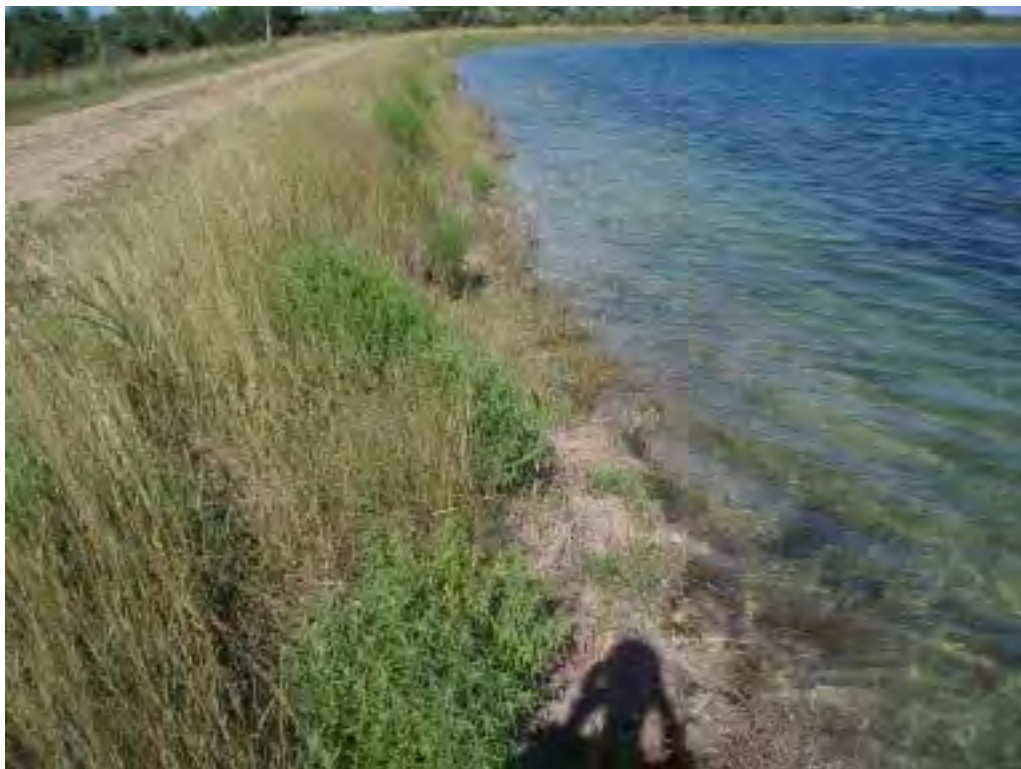
Photo No. 43: Secondary Pond – North embankment interior slope, looking east at typical 1 to 2 feet of erosion from wave action.

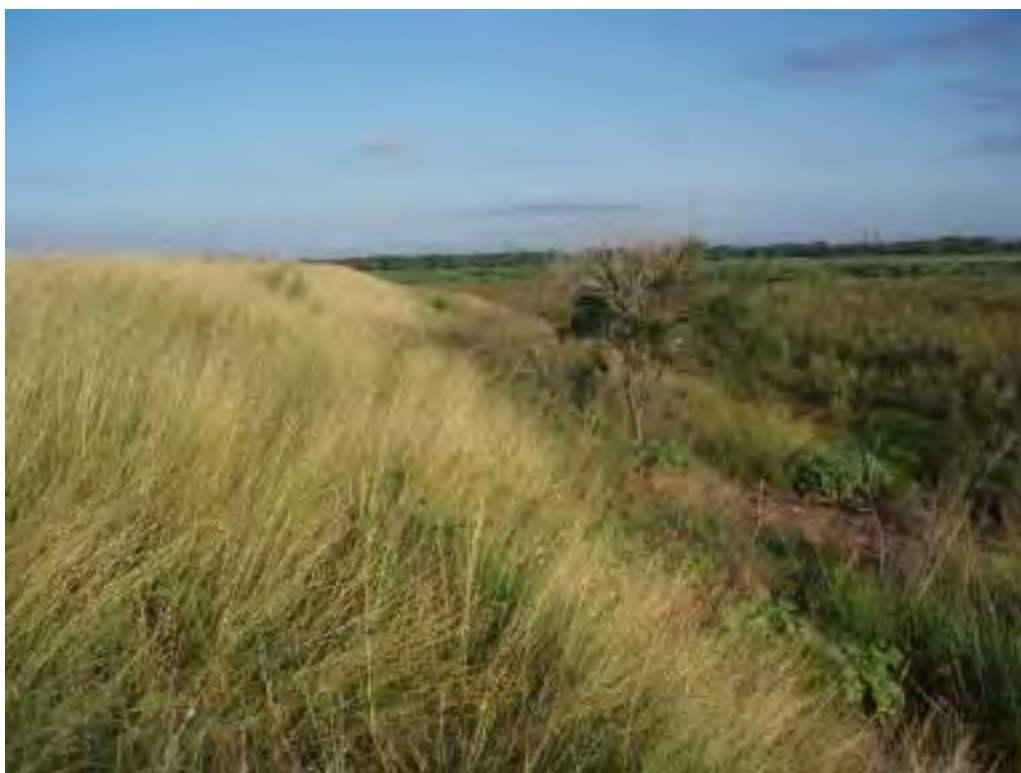
The north, west, and east embankments were generally covered with grass and small brush approximately 24 to 48 inches tall. On the north and west embankments there were 6- to 12-inch-diameter mesquite trees on the slope (Photos 52, 62, and 66). Smaller mesquite trees, 1 to 2 inch inches in diameter were observed on the east embankment. On the north embankment, areas of well-established vegetation were observed (Photo 53). The southwest, south, and southeast embankments were covered with grass approximately 6 to 12 inches tall.

Photo No. 52: Primary Ash Pond - North embankment exterior slope, looking west at tall grass and 6-inch-diameter mesquite tree.

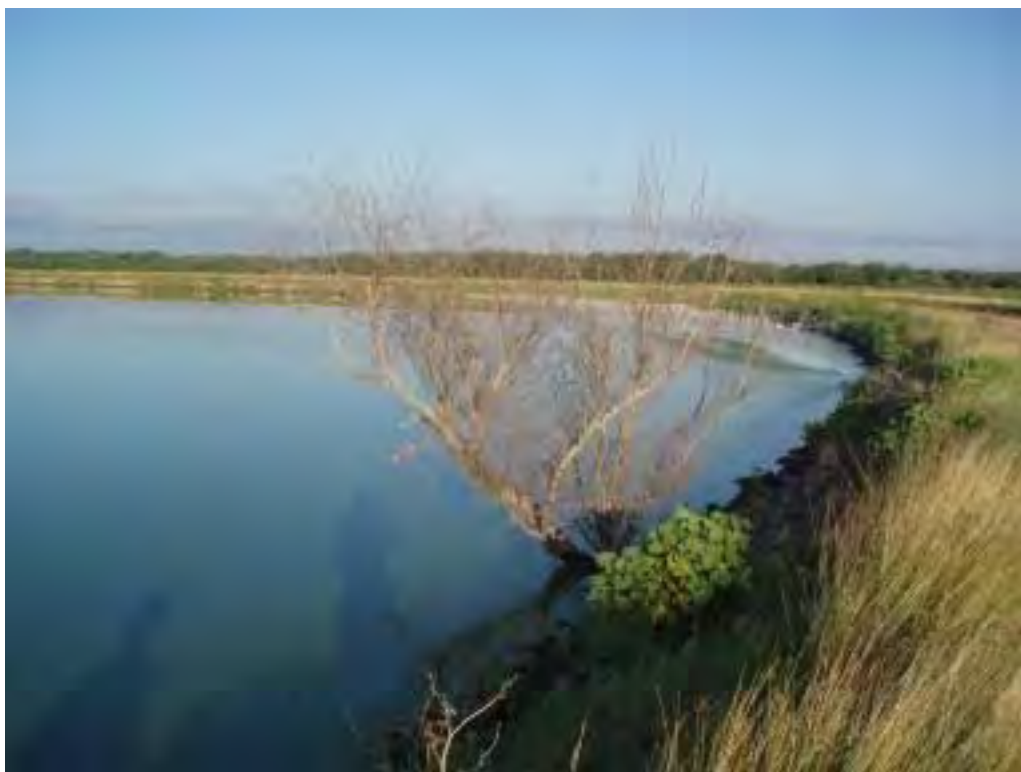
The visible portions of the interior slope generally appeared to be in fair condition (Photos 3, 9, 10, 12, 13, 51, 54, 58, 61, 64, 70, 74, 78, 79, 85, 87, 88, 93, 94, 101, 102, 110, 113, and 116). The north, east, and west interior slope and southwest slope of the divider embankment generally appeared to be armored with a layer of riprap. No riprap was observed on the southern embankments. Grass and brush approximately 24 to 36 inches tall was observed growing in the riprap. An 8-inch-diameter mesquite tree was observed on west end of the north embankment (Photo 54).

Photo No. 54: Primary Ash Pond - North embankment interior slope, looking west at a dead 8-inch-diameter mesquite tree.

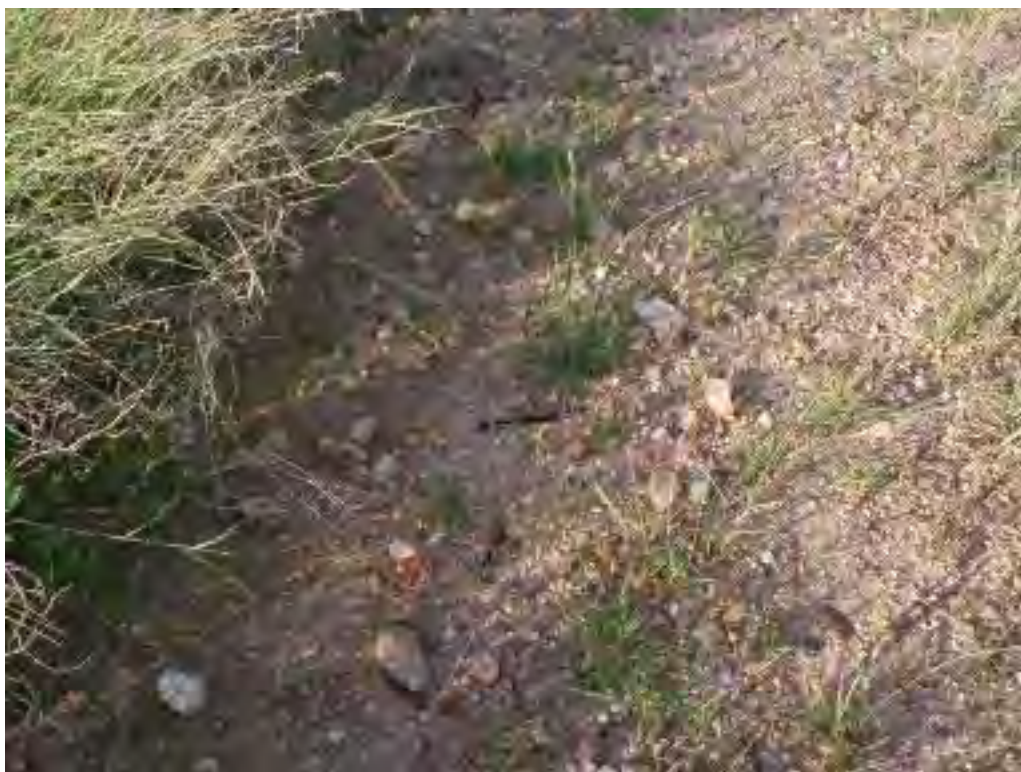
Photo No. 68: Primary Ash Pond – West embankment crest, looking at typical desiccation crack.

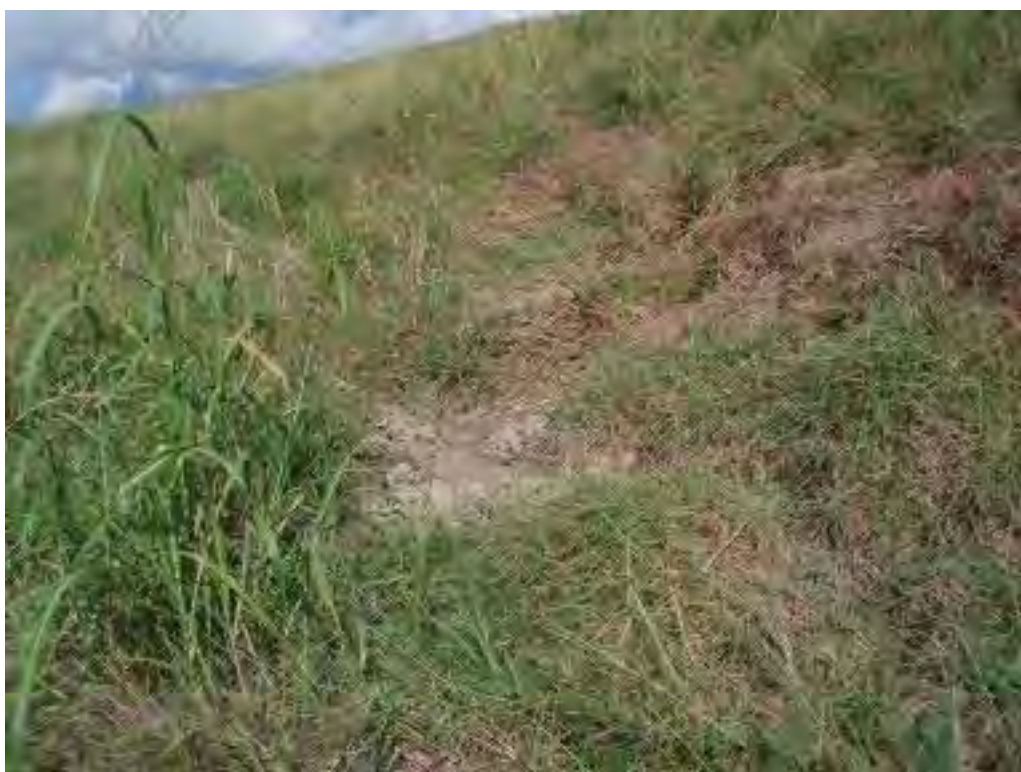
On the southeast embankment two seeps were observed. One of the seeps appeared to have developed at the location of an 8-inch-diameter animal burrow (Photo 97). The other seep observed on the southeast embankment was near the toe of the slope and was approximately 8-feet-long by 2-feet-wide (Photo 98). Flow from the seeps was visually estimated to be averaging less than 10 gallons per day (gpd).

Photo No. 98: Primary Ash Pond – Southeast embankment exterior slope, looking at 8'Lx2'W seep near toe.

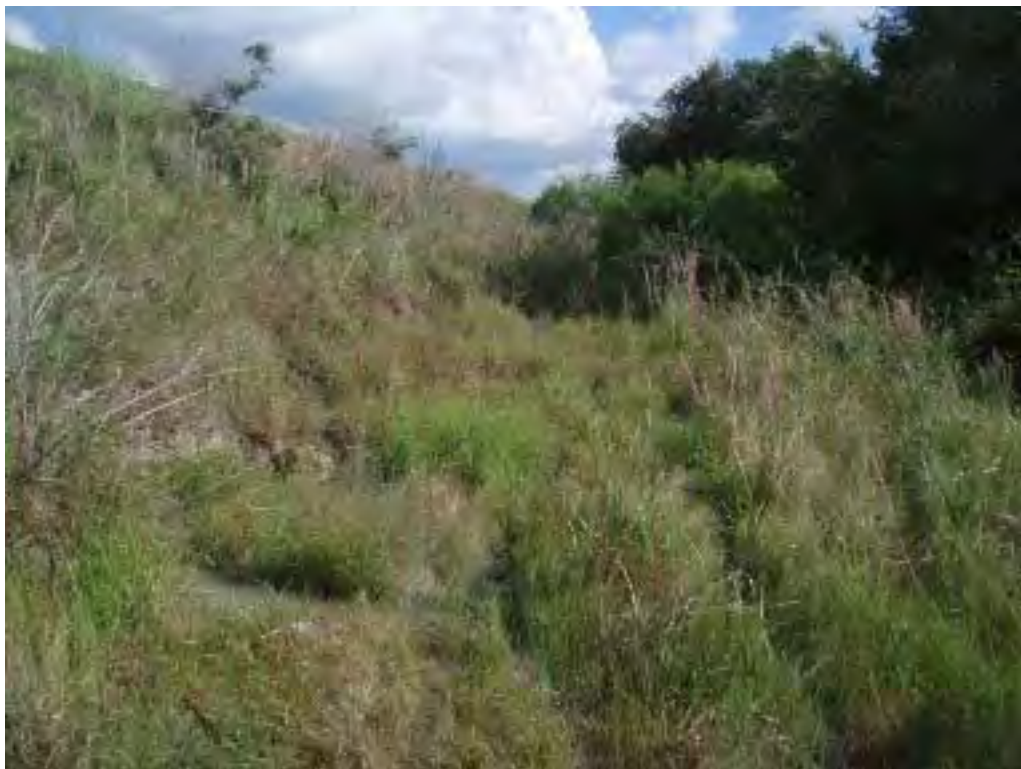
There were multiple seeps observed on the east embankment exterior face and in the toe area. An approximately 40-foot-long by 10-foot-wide seep was observed on the lower third of the slope (Photo 105). To the north of that seep there were more minor seeps that were less than 2-feet-wide and observed near the toe of the slope. These seeps appeared dry and crusted at the time of the site visit. A surface depression approximately 4 feet long by 4 feet wide by 2 feet deep was also observed in the area (Photo 106) of these seeps. A large seepage area approximately 400 feet long by 20 feet wide was observed at the embankment toe area (Photos 107 and 108). The seepage area was saturated, soft, and boggy with standing water up to 12 inches in depth. Well established vegetation, mesquite trees, and hog wallows were also observed in this seepage area. Seepage rates could not be visually estimated in the area of this large seep due to its extent.

Photo No. 107: Primary Ash Pond – East embankment exterior slope, looking north at beginning of approximately 400-foot-long seepage area. Note area is saturated, soft, with standing water and lush vegetation. Isolated hog wallows were observed in the seepage area.

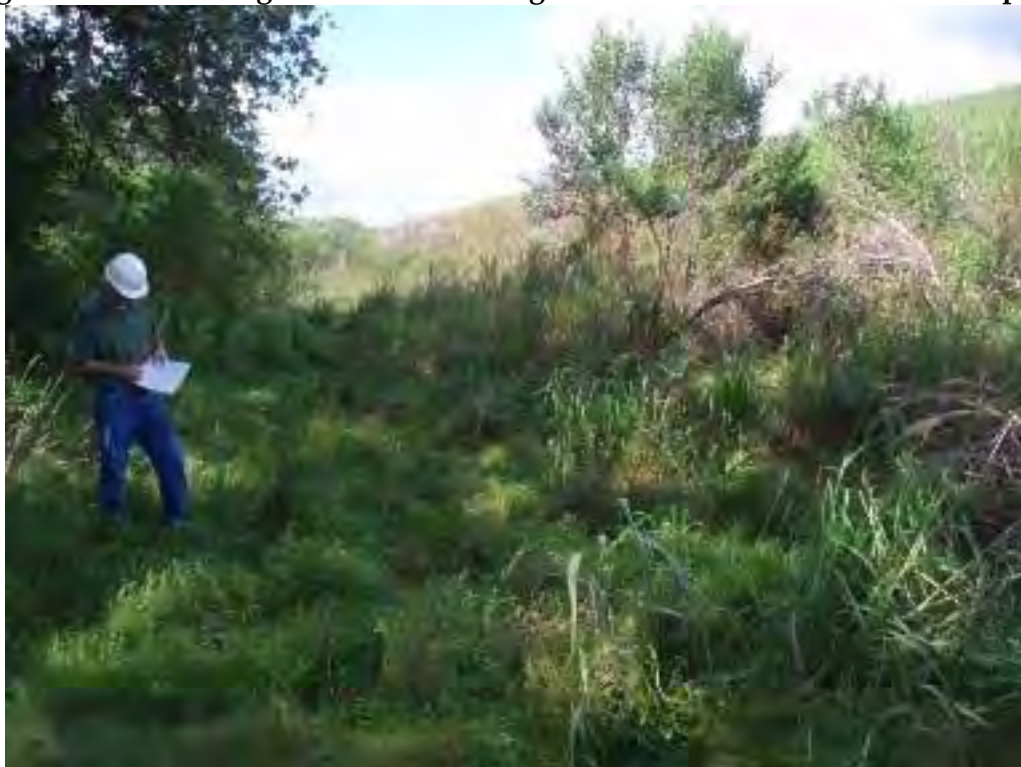
Photo No. 108: Primary Ash Pond – East embankment exterior slope, looking south at end of approximately 400-foot-long seepage area.
